# Refractory Wear Characterization in Lime Recovery Kilns

James G. Hemrick (Oak Ridge National Laboratory)

# Post-Mortem Examination

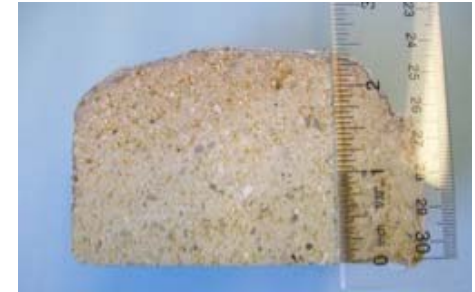
- Sample of brick removed from a 3.6 m diameter kiln
- Low-corundum content 60% alumina brick
- Refractory wear within the kiln localized between 7.6 and 12.2 m from the discharge displaying “duck nesting”

- Dominant phase - anorthite ( $\text{CaOAl}_2\text{O}_3\text{2SiO}_2$ )
- Top phases reactions with calcia
- Nepheline only a minor component ( $\text{Na}_3\text{KAl}_4\text{Si}_4\text{O}_{16}$ )

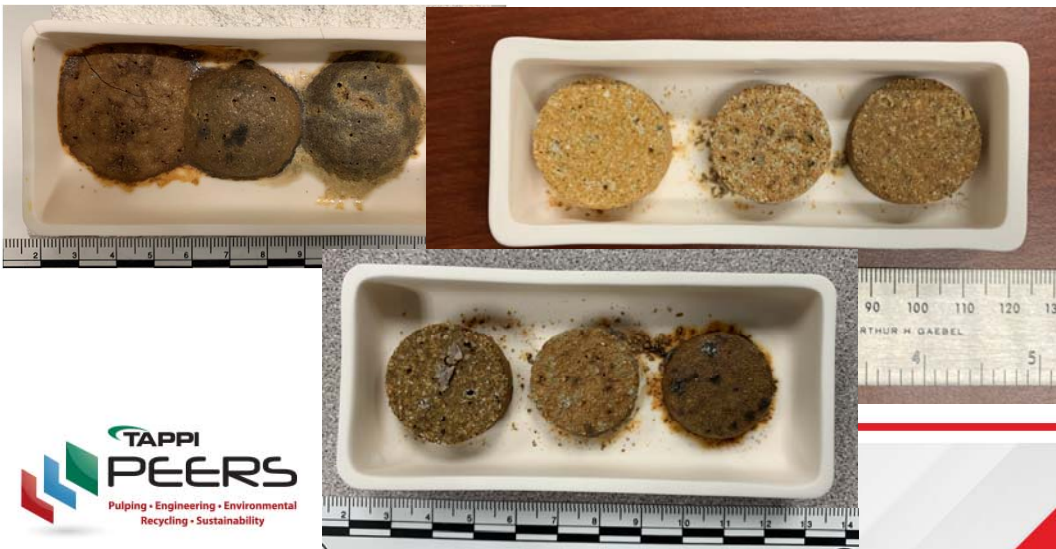
- Formation of calcium-alumino-silicate phase (anorthite) was observed
- 70% alumina refractory was the worst performing material in this test

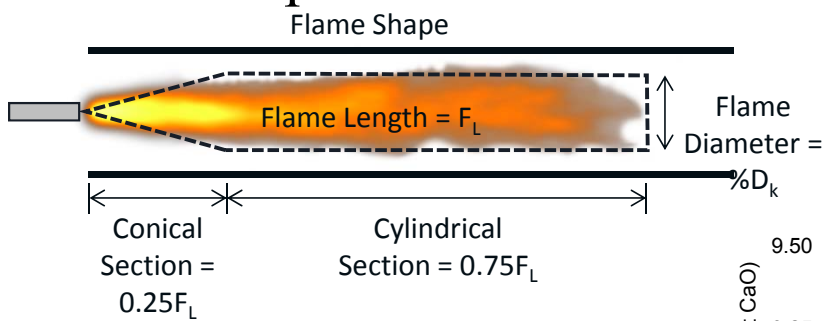
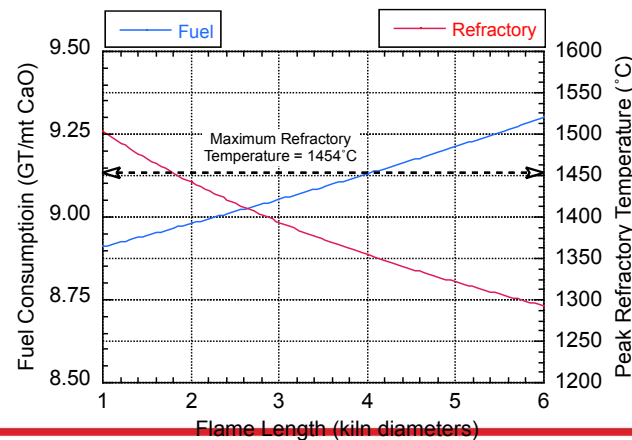
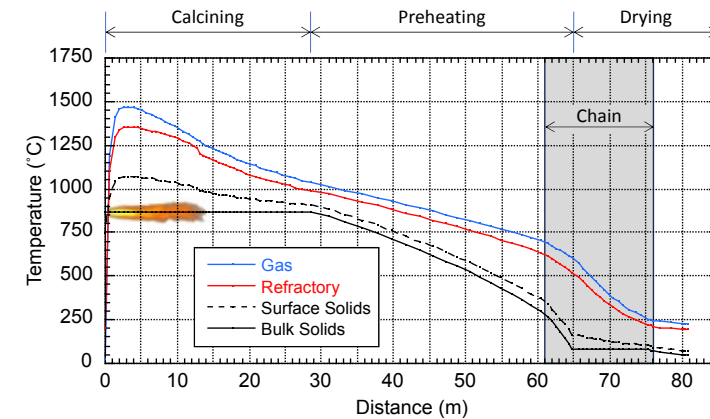
- Burner design should promote flame lengths of about 4 kiln diameters long and that the longer flame substantially reduces the refractory temperature

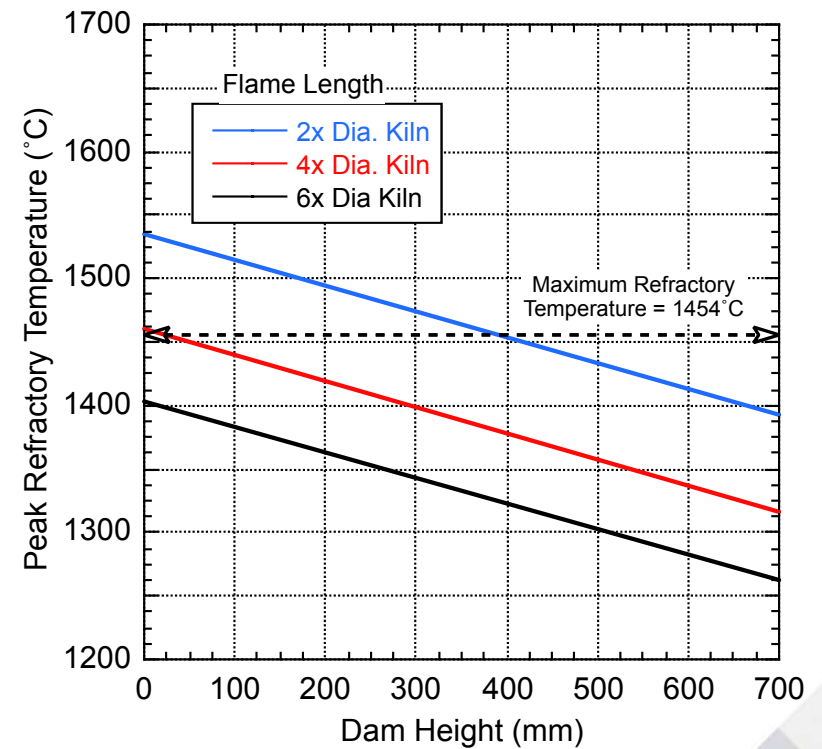
- Discharge end dam protects the refractory from overheating due to the increased bed depth of the lime charge in the kiln and both coolers and insulated linings decrease the safety factor for the refractory in terms of the potential for overheating

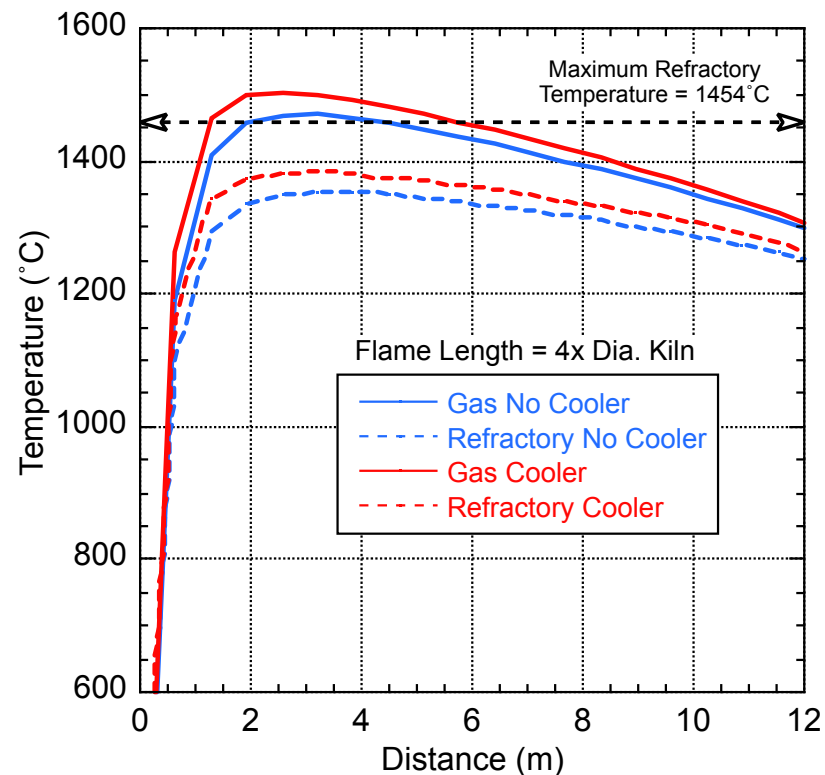
- The use of product coolers increases the temperatures of the gas and refractory lining, thereby reducing the safety factor of overheating the refractory lining

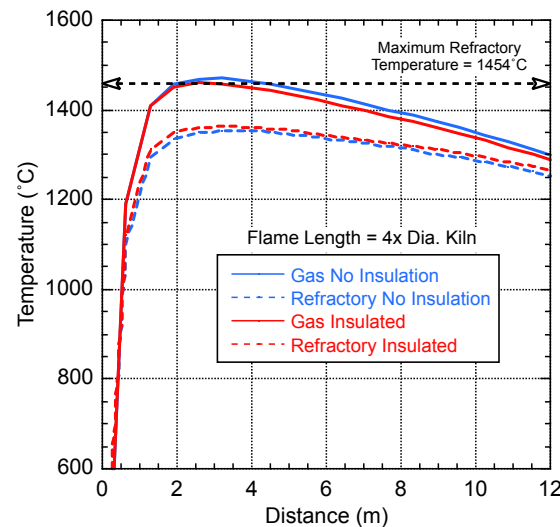
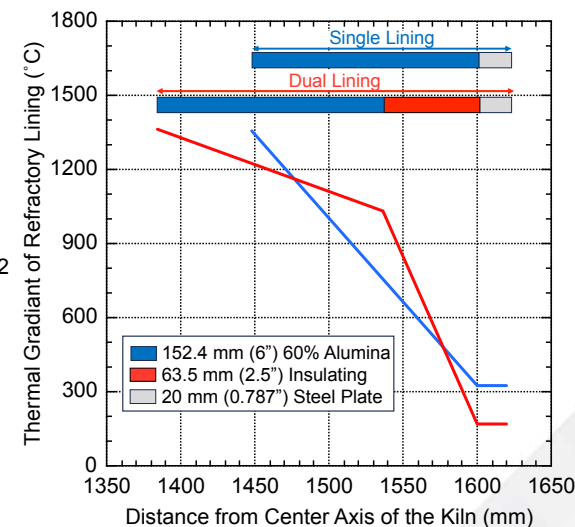
- Insulating the lining has a minor impact on the peak temperature of the refractory
- Addition of insulating the lining has more impact on the radial temperature gradients
- Use of insulation increases the internal temperature of the working lining allowing the alkali to more deeply penetrate into the lining
