# Refractory Wear Characterization in Lime Recovery Kilns

James G. Hemrick (Oak Ridge National Laboratory)

# Post-Mortem Examination

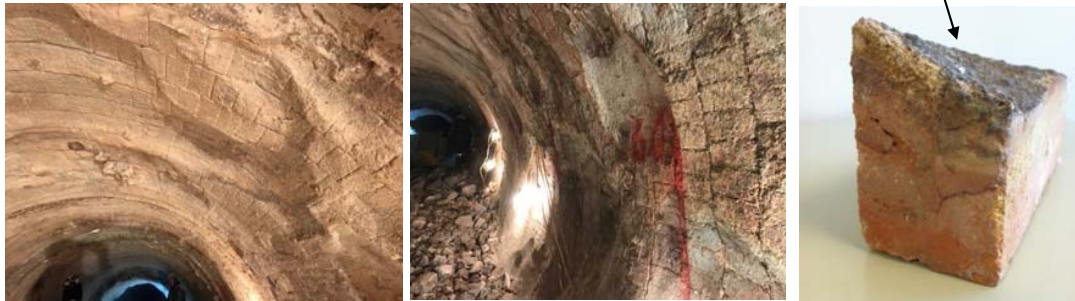
- Refractory lined vessel utilizing 60% or 70% alumina refractory bricks which provide a balance between refractoriness, chemical resistance, thermal properties, and cost
- Accelerate wear or “duck nesting” often experienced upsetting kiln operations and leading to unscheduled outages
  - Widely believed that excess alkali carryover in the lime kiln feed plays a major role in these failures, but this work examines the root cause of these failures

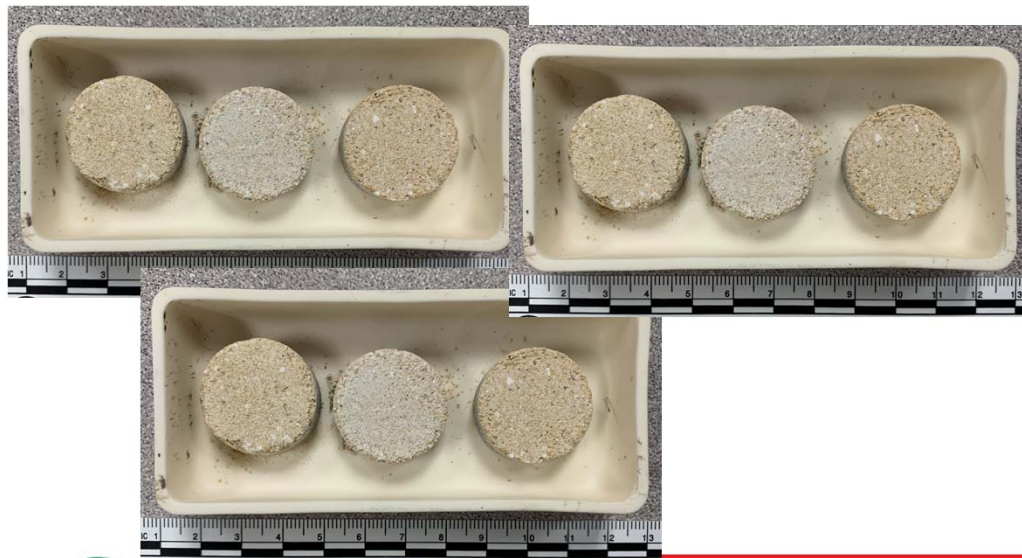
- Laboratory testing proposed to explore the premise that it may not be alkali ( $\text{Na}_2\text{O}$ ) that leads to erosive wear of the refractory linings, but that it may actually be fluxing due to  $\text{CaO}$  that causes such wear
- Additionally, the degree of reaction at various temperatures was explored

- Pressed pellets fired in an air furnace (Deltech DT-31-FL-10-E3504)
- Samples heated at  $5^\circ\text{C}/\text{min}$  to temperature, held for 1 hour and then cooled at  $10^\circ\text{C}/\text{min}$  back to room temperature

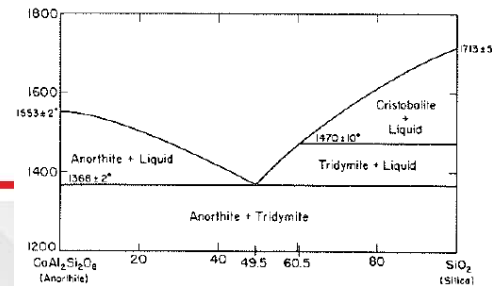
- Lime mud reacted with brick powder of all three refractory brick compositions with higher temperatures producing more reaction, as was expected
- X-ray diffraction showed that anorthite ( $\text{CaOAl}_2\text{O}_3\cdot 2\text{SiO}_2$ ) was the dominant mineral formed consistent with post-mortem evaluations
- Less reaction of 60% alumina refractories, in comparison to 70%, is consistent with previous corrosion cup testing that suggested superior wear resistance of 60% alumina bricks in the calcining zone of the kiln
- Surmised that liquid formation begins to occur as early as  $1365\text{-}1370^\circ\text{C}$  ( $2489\text{-}2498^\circ\text{F}$ ) based on a eutectic

4. It was surmised that liquid formation may begin to occur in these samples as early as 1365-1370°C (2489- 2498°F) based on a eutectic found in the anorthite-silica phase diagram and leading to the behavior observed both experimentally in the laboratory and through post-mortem examinations.

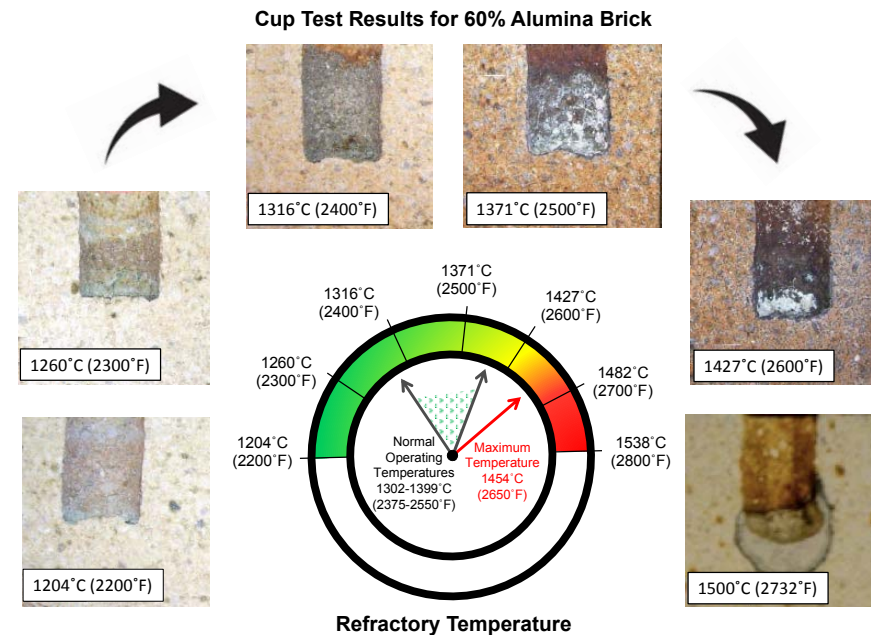
- Finally, it was determined that while levels of alkali play a role, in the end, the temperature of the refractory and interactions with calcium compounds from the lime mud have a larger impact on the service life of the lining.

The maximum operating temperature is 1454°C (2650°F).

- It was found that burner design should promote flame lengths of about 4 kiln diameters long and that the longer flame substantially reduces the refractory temperature.
